CASE STUDY

Location: Car Wash Tunnel, Boston, Massachusetts
Application: Vent Covers and Trench Covers
Product: Chemgrate® Molded Grating, Chemplate® Molded Plate

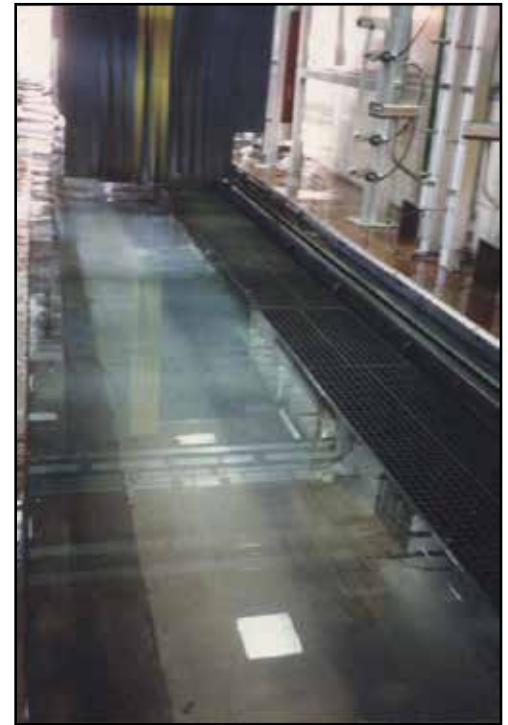
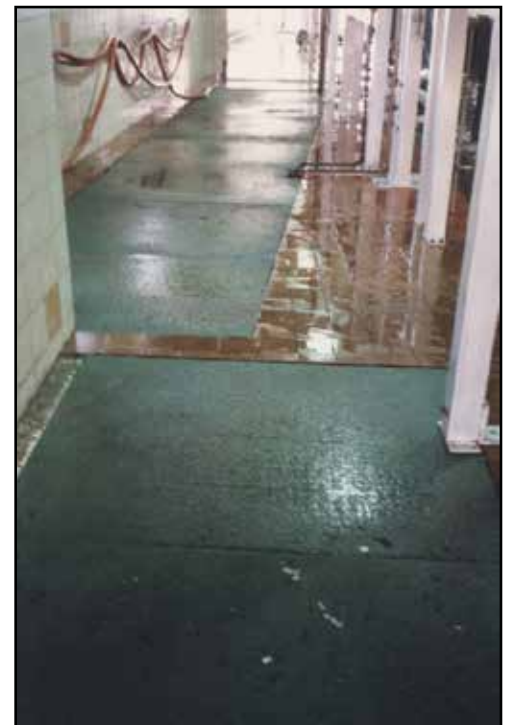
Fibergrate installed Chemgrate® 1-1/2" deep, 1-1/2" square mesh molded grating. The grating's resin, CP-84, is a chemical-grade premium polyester resin that offers excellent corrosion resistance. Therefore, the FRP (fiberglass reinforced plastic) grating would not be affected by the soap and chemicals, which attack steel and aluminum grating. Offering a slip-resistant surface, this grating provides a solid under footing in all kinds of slippery conditions, including grease, water, oil, chemicals and waste material. The carwash owners were extremely pleased with the results. The light-weight property of the grating made it simple to remove for inspections and cleaning purposes. Most important was the fact that the grating does not rust nor does it require treatment to prevent rust.

In addition, several vehicles which jumped the track did no structural damage to the grating. This is due to the integral makeup of continuous fiberglass strand interwoven throughout the panel and laid in a matrix of high quality resin. The carwash owners also utilized Chemplate® to cover their water recovery tanks providing a safe, slip-resistant walking surface for their employees.
